**CONSENT ORDER
ISSUED UNDER THE
WATER POLLUTION CONTROL ACT
WEST VIRGINIA CODE, CHAPTER 22, ARTICLE 11**

TO: MarkWest Liberty Midstream & Resources, L.L.C. DATE: March 28, 2019
Gregory Bezdek, SVP, NE Region
4600 J Barry Ct. Ste 500
Canonsburg, PA 15317 ORDER NO.: 8945

MARKWEST LIBERTY MIDSTREAM & RESOURCES, L.L.C, WVR311004, Sherwood to Mobley
20" NGL, 8/22 & 8/23/2018

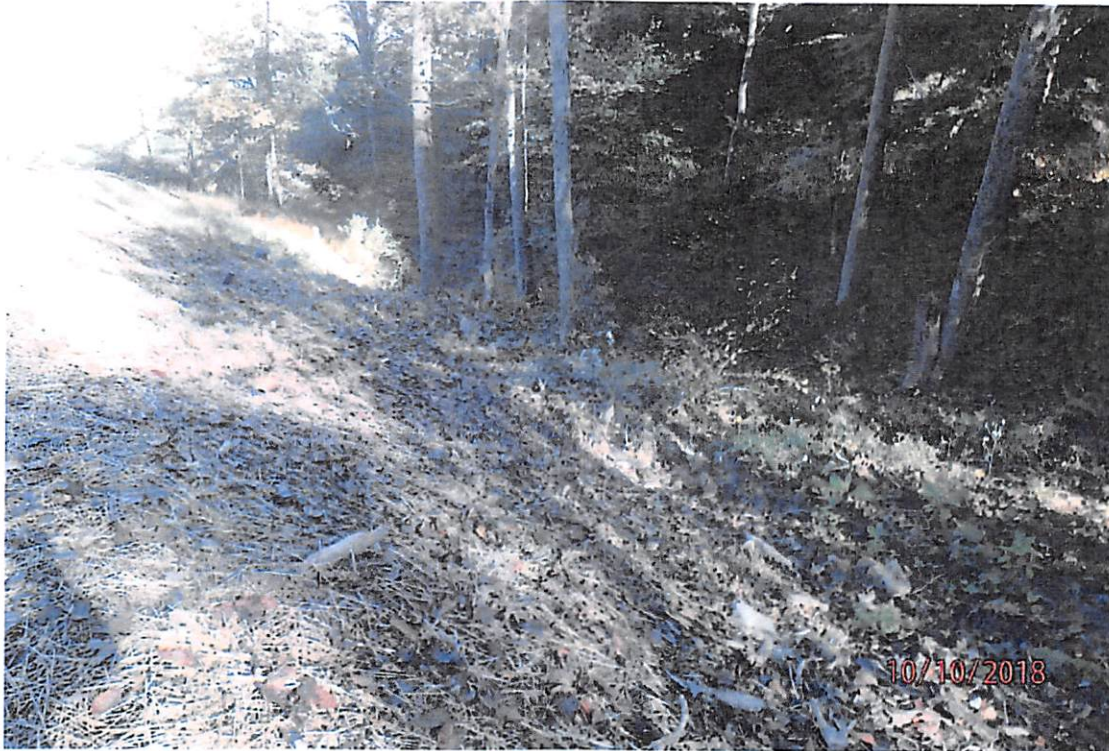
Area adjacent to 142+00 where BMPs are not indicated in the approved SWPPP and the SWPPP needs to be modified in order to prevent sediment laden water from leaving the site.

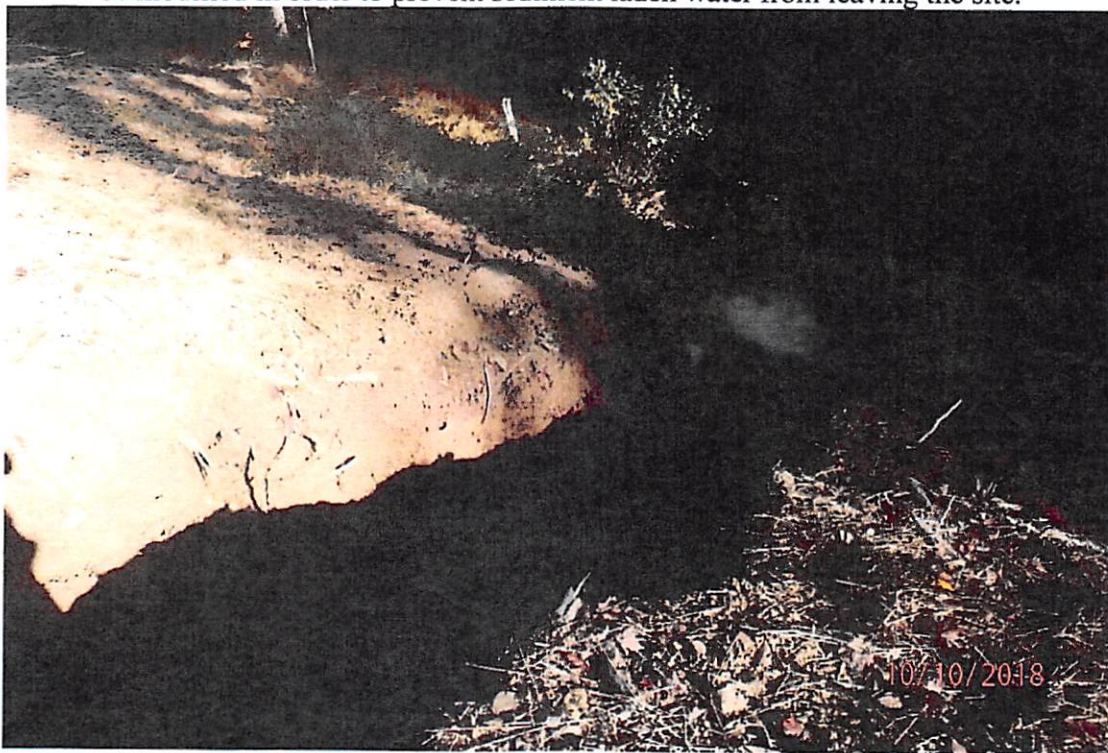
Area adjacent to 142+00 where BMPs are not indicated in the approved SWPPP and the SWPPP needs to be modified in order to prevent sediment laden water from leaving the site.

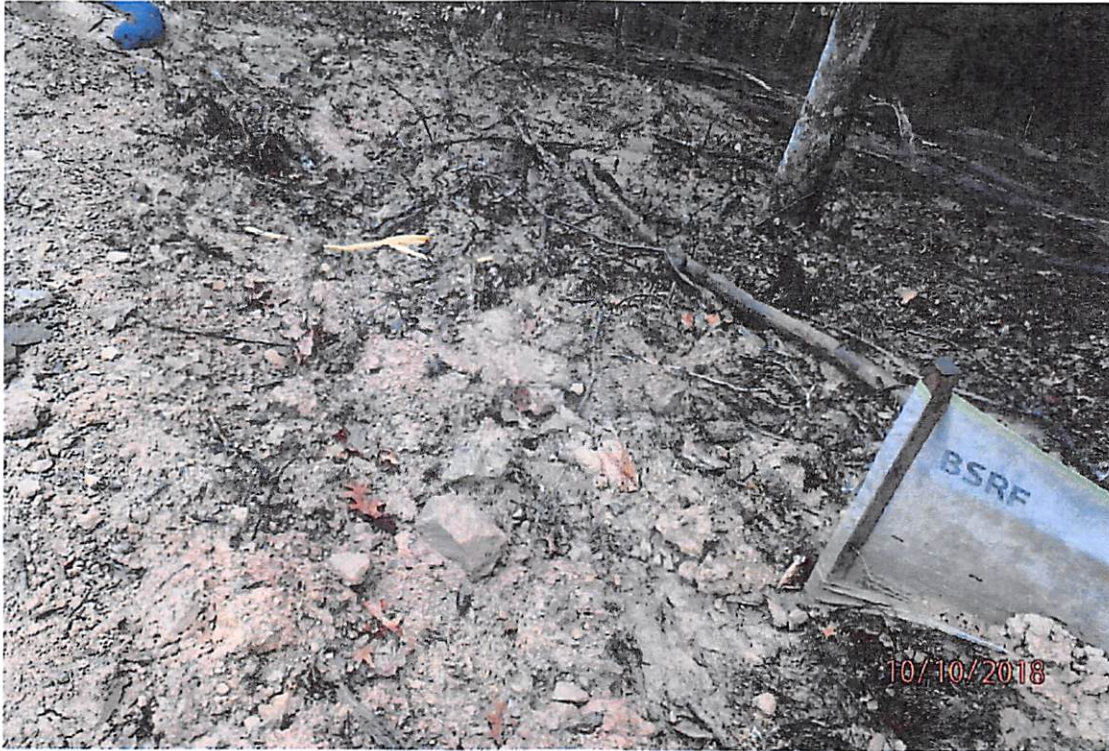
Area adjacent to 415+00 where BMPs are not indicated in the approved SWPPP and the SWPPP needs to be modified in order to prevent sediment laden water from leaving the site.

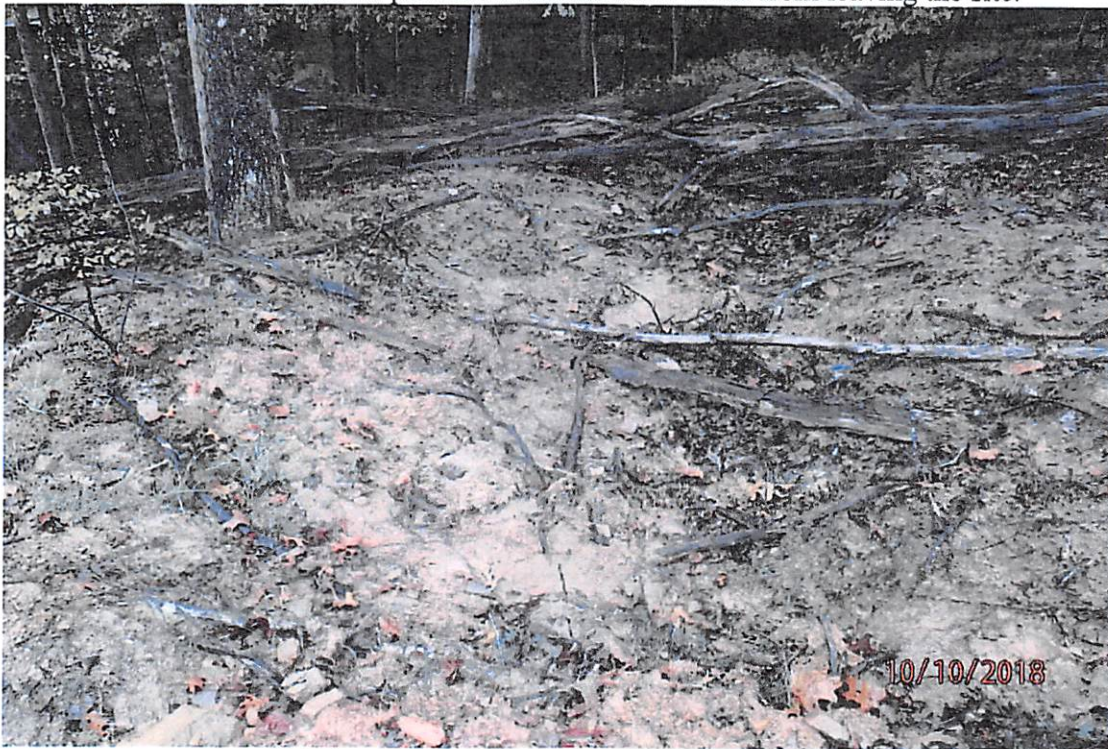
Offsite sediment deposits adjacent to 415+00.

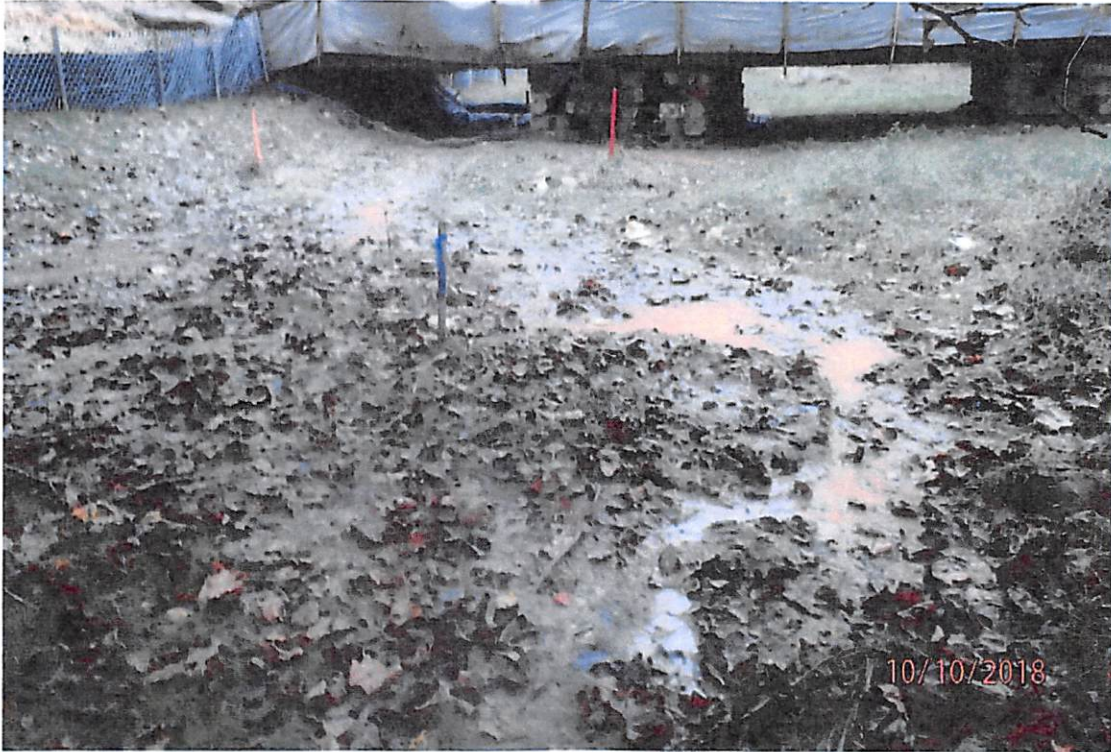
Area adjacent to UNT Riggins Run where the approved SWPPP does not indicate the need for a BMP and sediment laden water is leaving the site with no device in place and causing CNA in the stream.

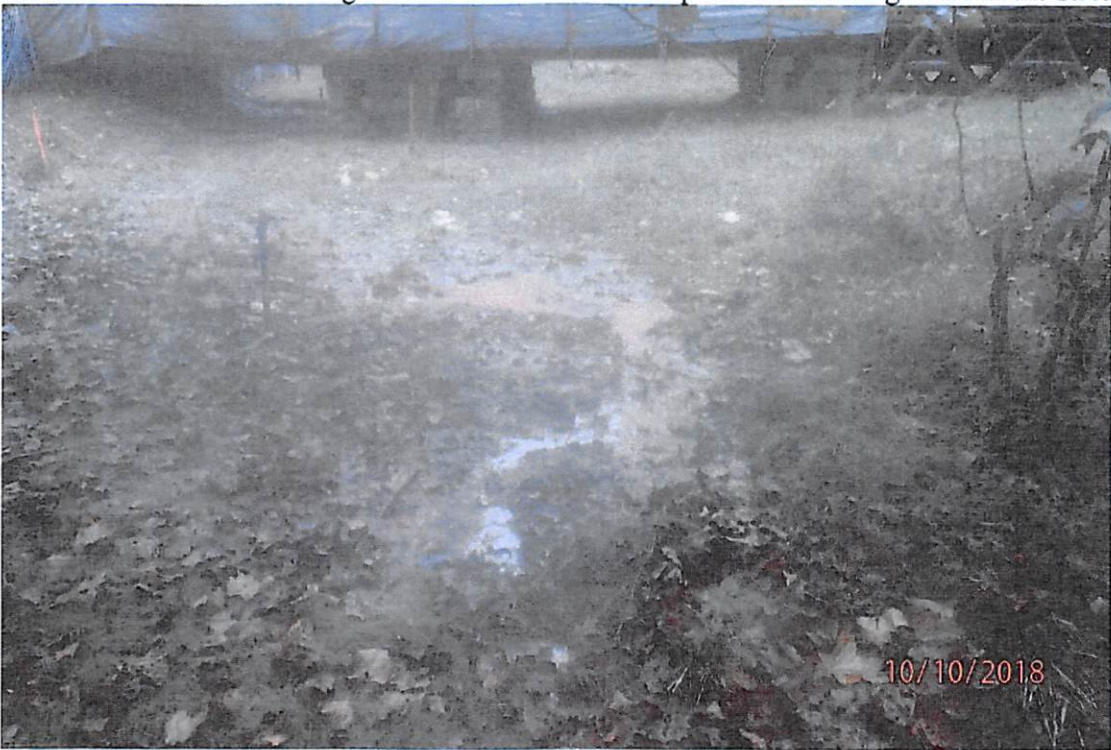
Area adjacent to UNT Riggins Run where the approved SWPPP does not indicate the need for a BMP and sediment laden water is leaving the site with no device in place and causing CNA in the stream.

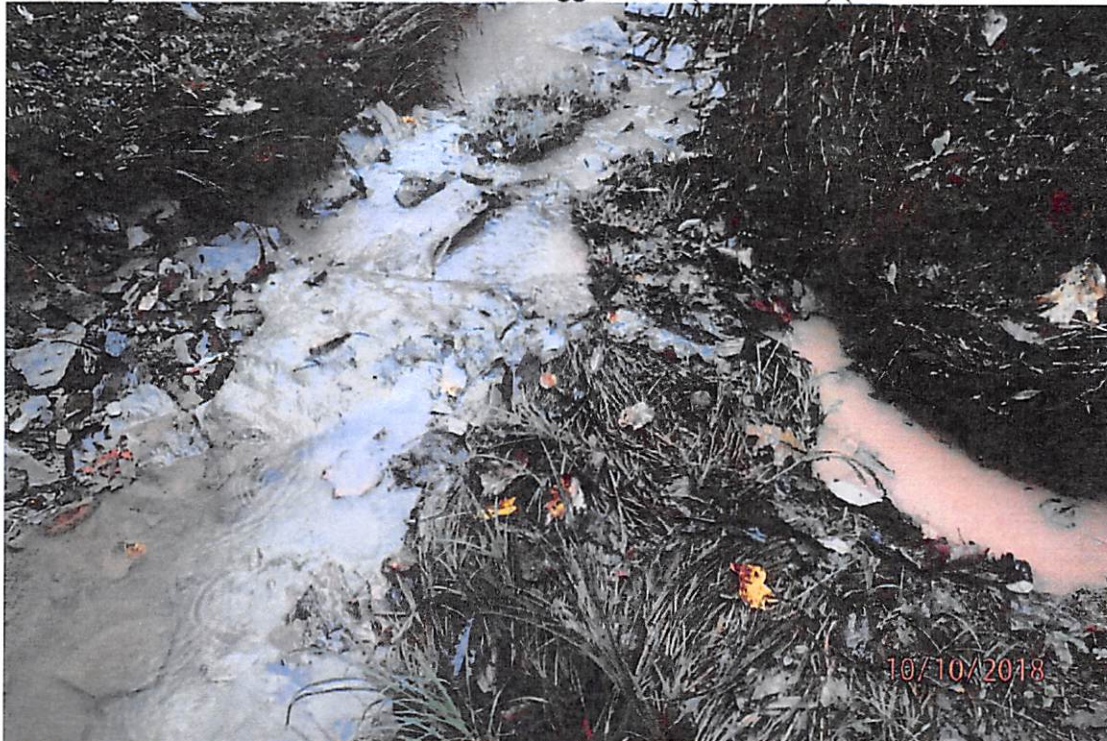
CNA distinctly visible settleable solids in UNT Riggins Run (UNT – 18) (39°22.075' X 80°39.463').

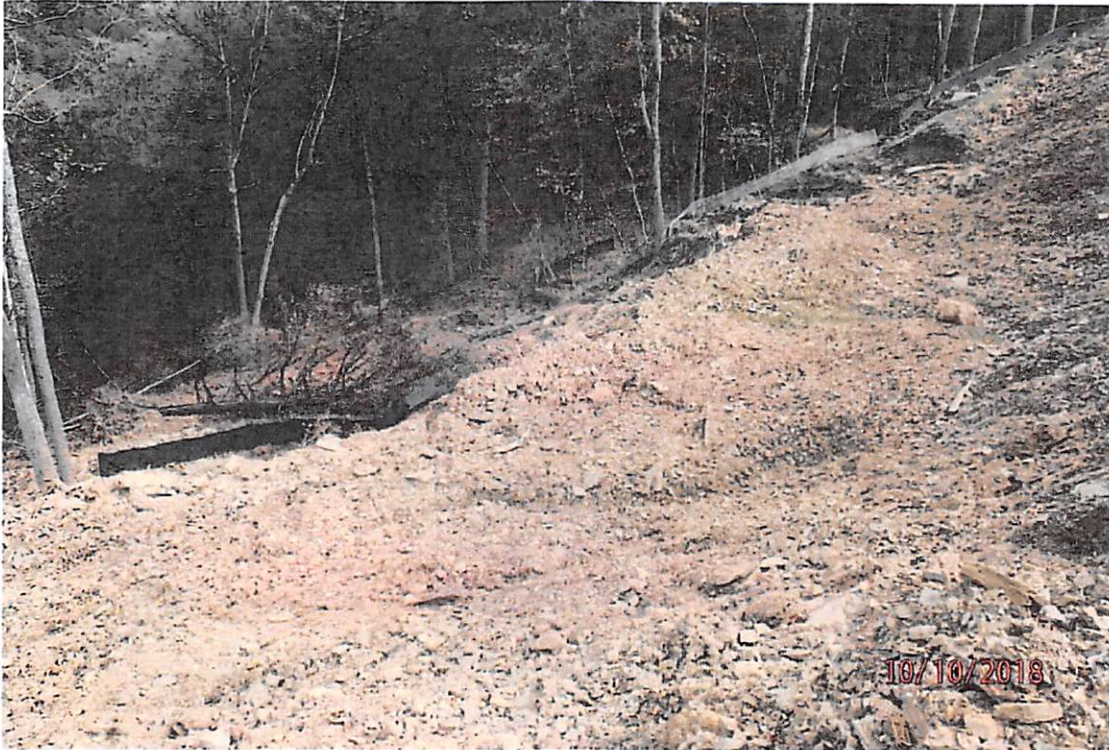
Offsite slip near 248+00.

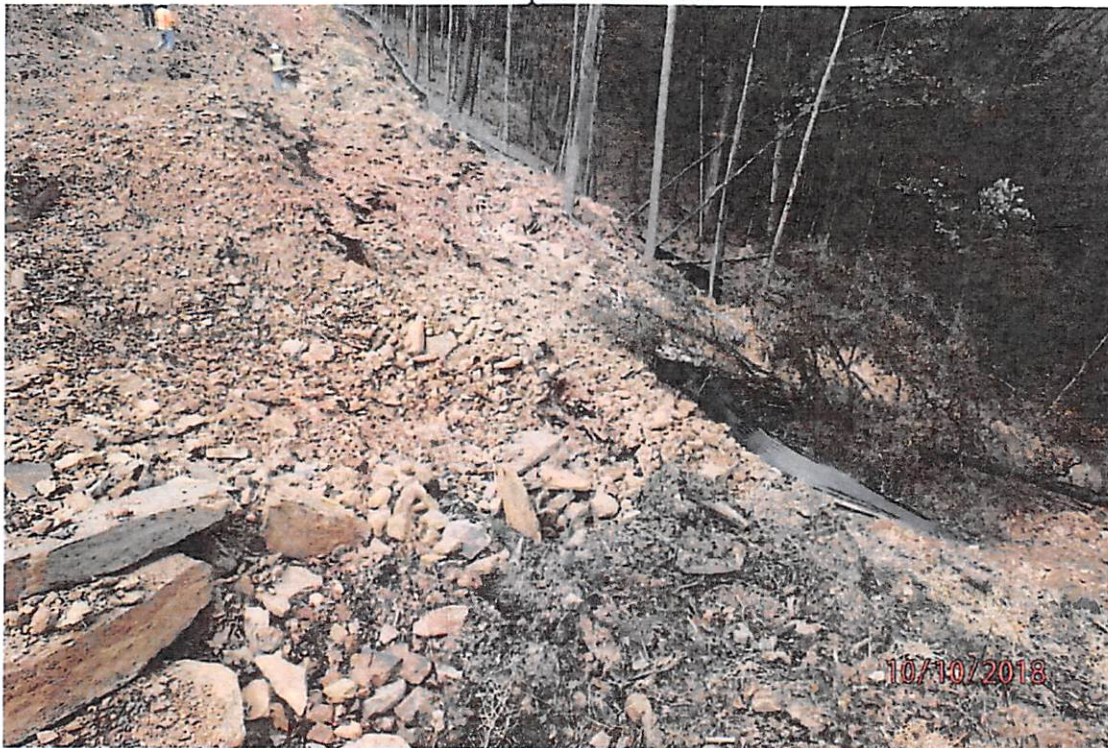
Offsite slip near 248+00.

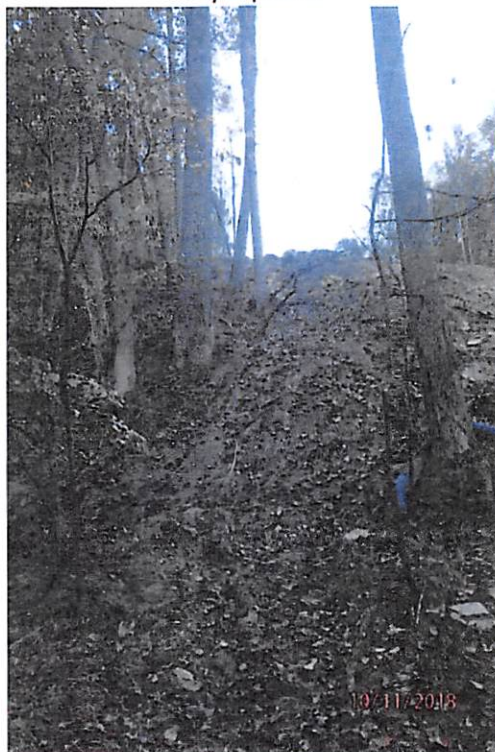
Offsite slip near 479+50.

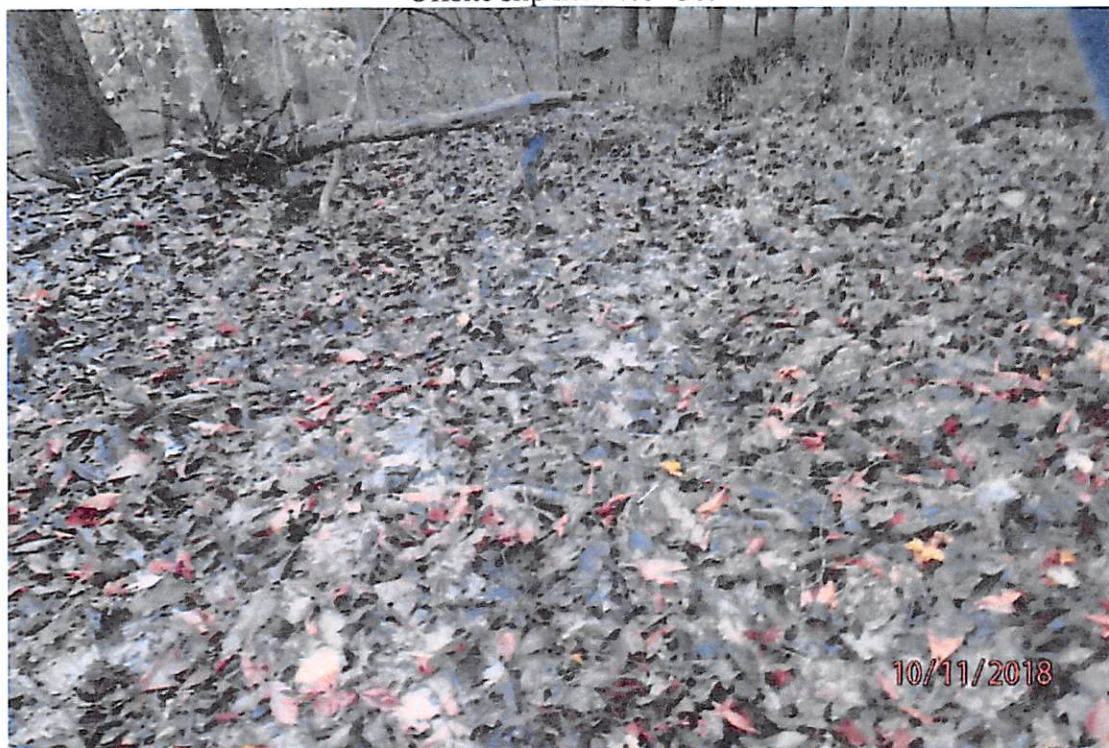
Offsite slip near 479+50.

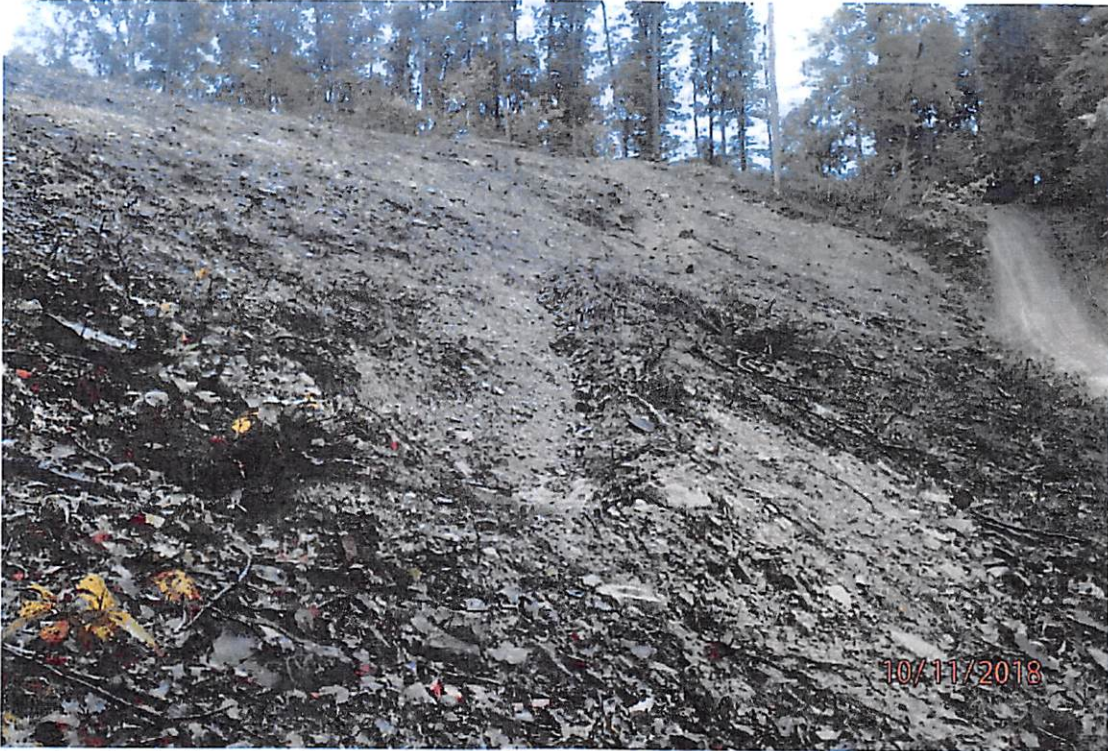
Water bar that lacks water bar terminus BMPs indicated in the approved SWPPP near 510+00.

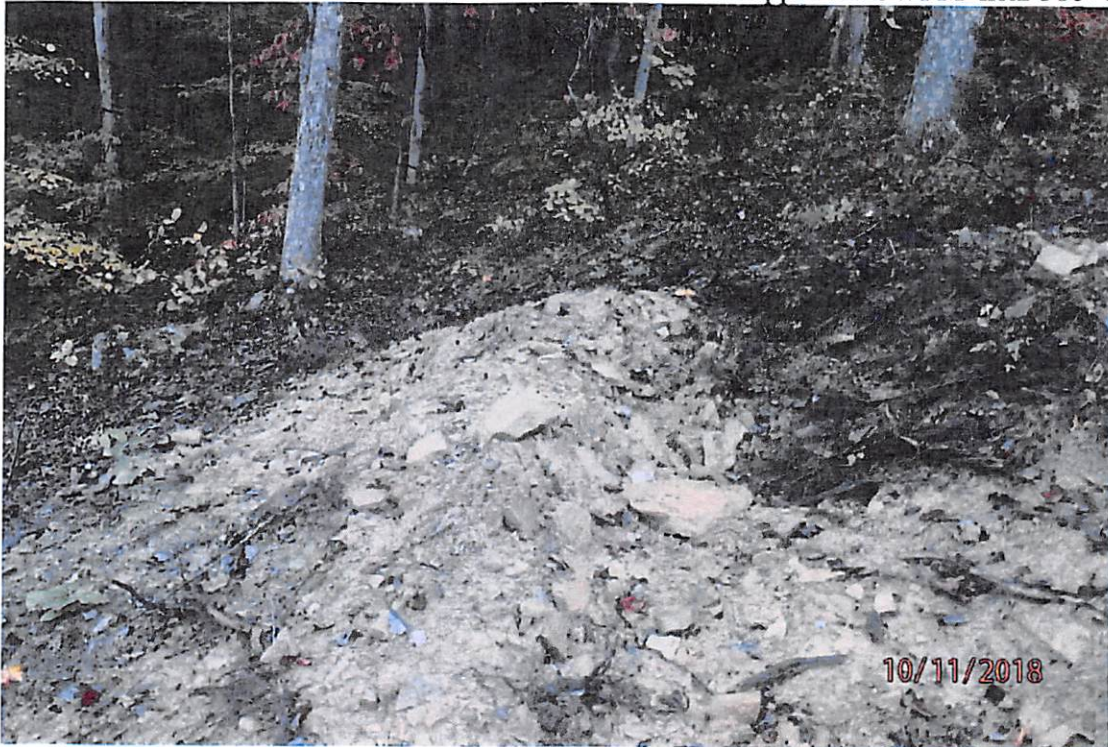
Water bar that lacks water bar terminus BMPs indicated in the approved SWPPP near 510+00.

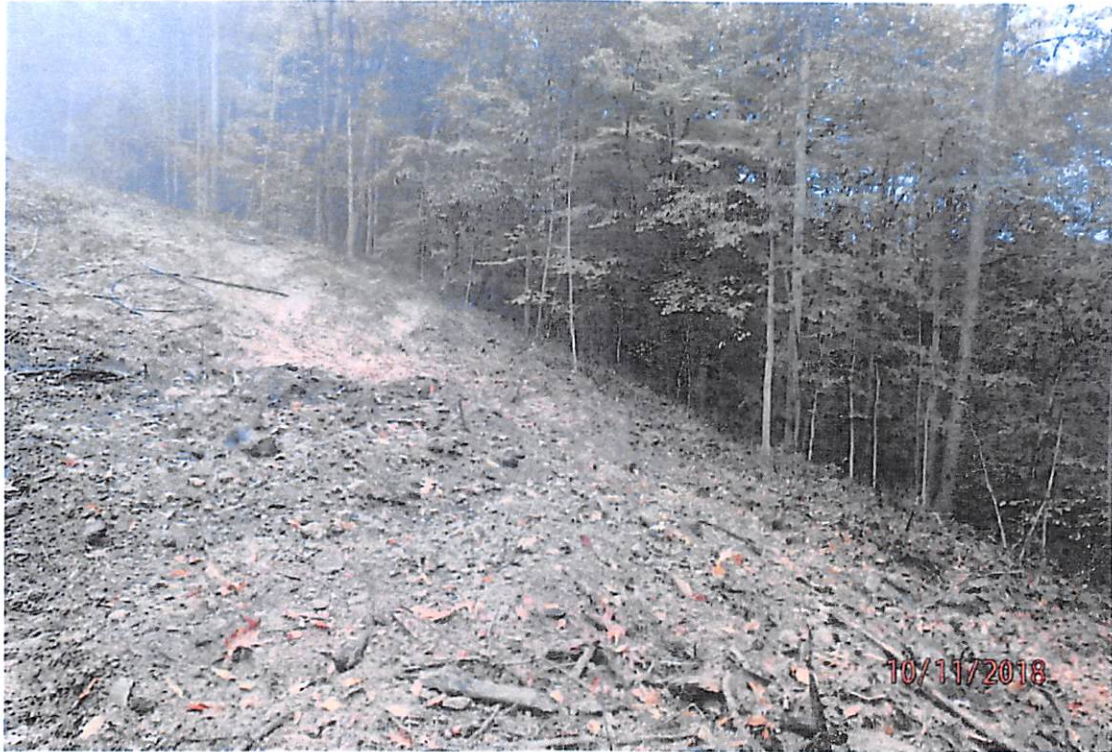
Area of disturbance from 561+00 to 588+00 that lacks water bar terminus BMPs and perimeter controls indicated in the approved SWPPP.

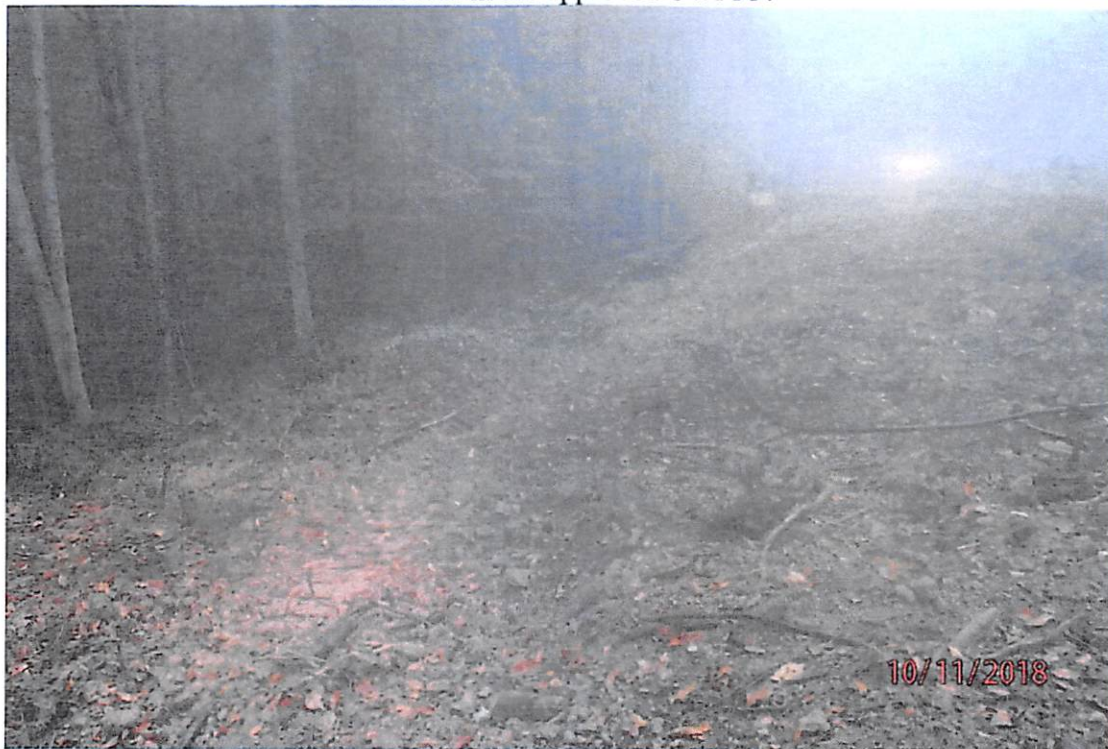
Area of disturbance from 561+00 to 588+00 that lacks water bar terminus BMPs and perimeter controls indicated in the approved SWPPP.

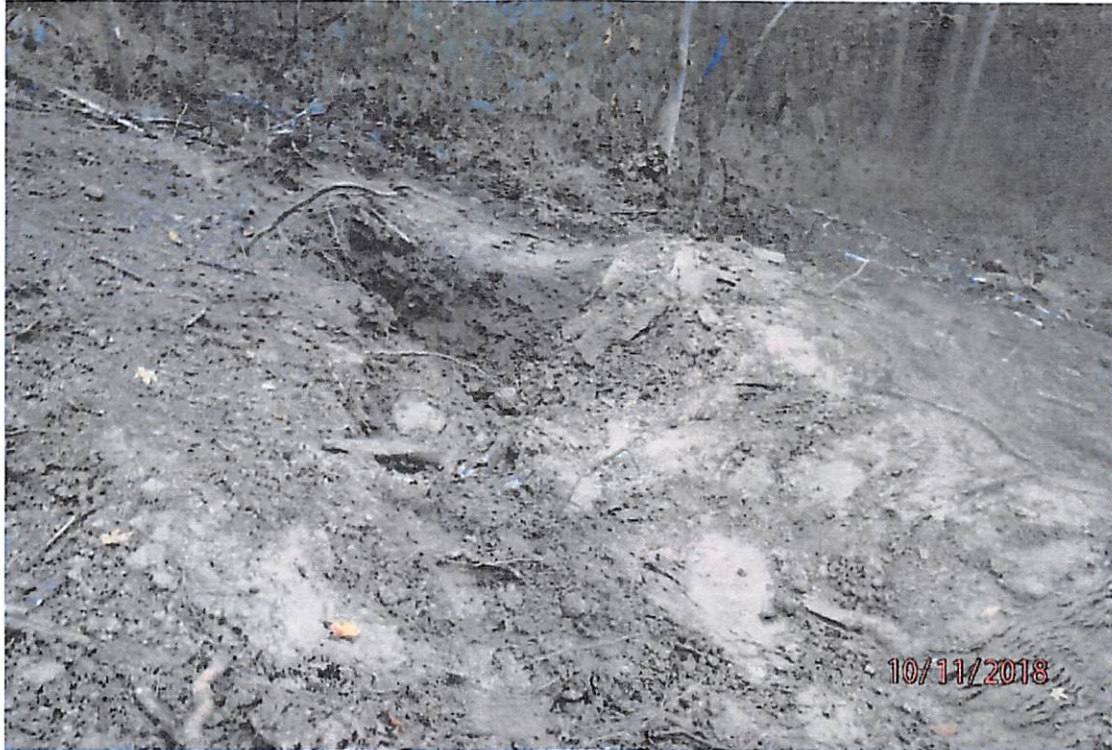
Area of disturbance from 561+00 to 588+00 that lacks water bar terminus BMPs and perimeter controls indicated in the approved SWPPP.

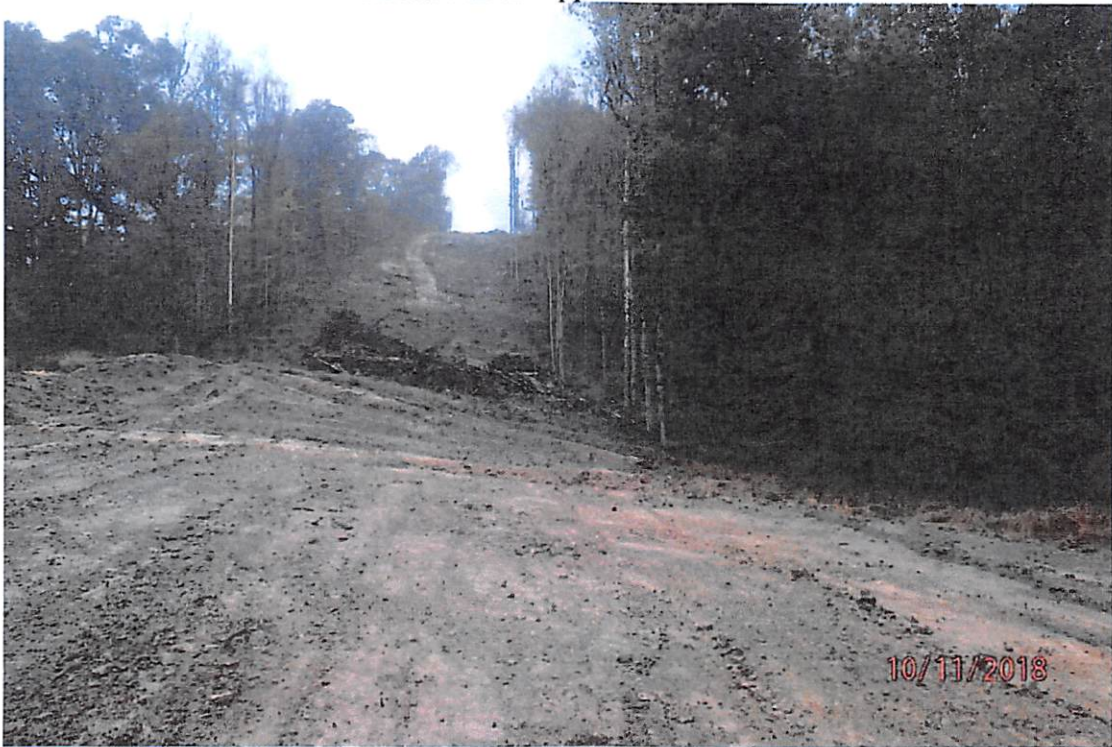
Area of disturbance from 561+00 to 588+00 that lacks water bar terminus BMPs and perimeter controls indicated in the approved SWPPP.

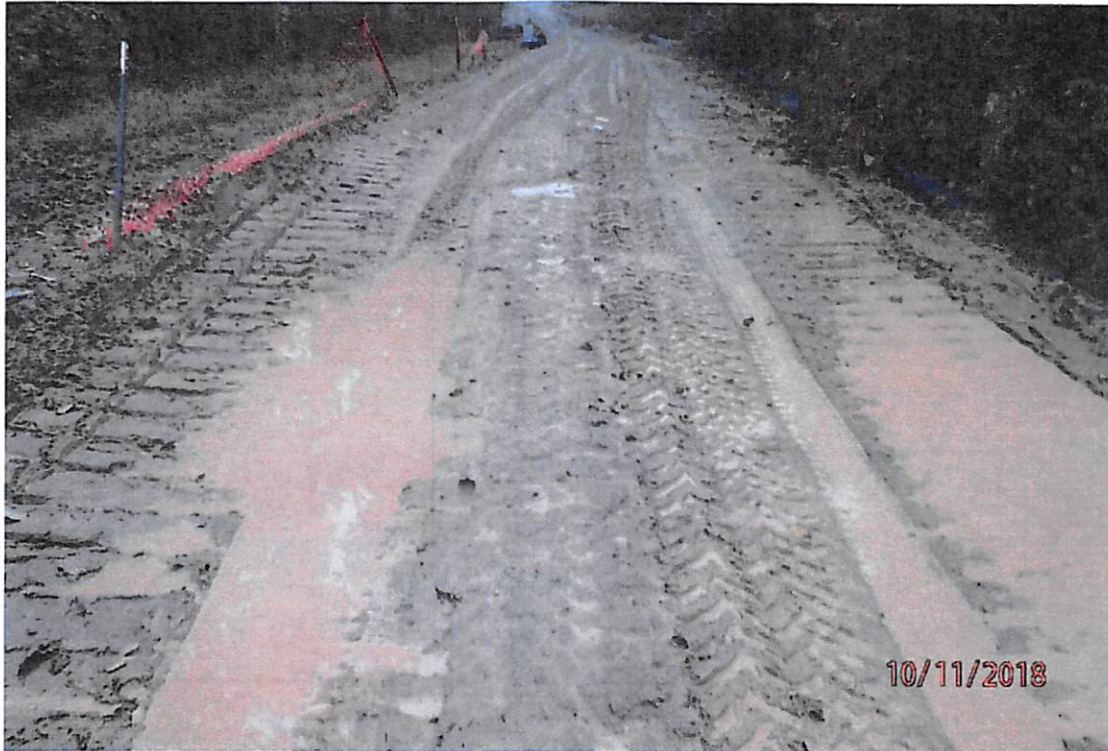
Access road 42 showing a lack of stone as indicated in the approved SWPPP.

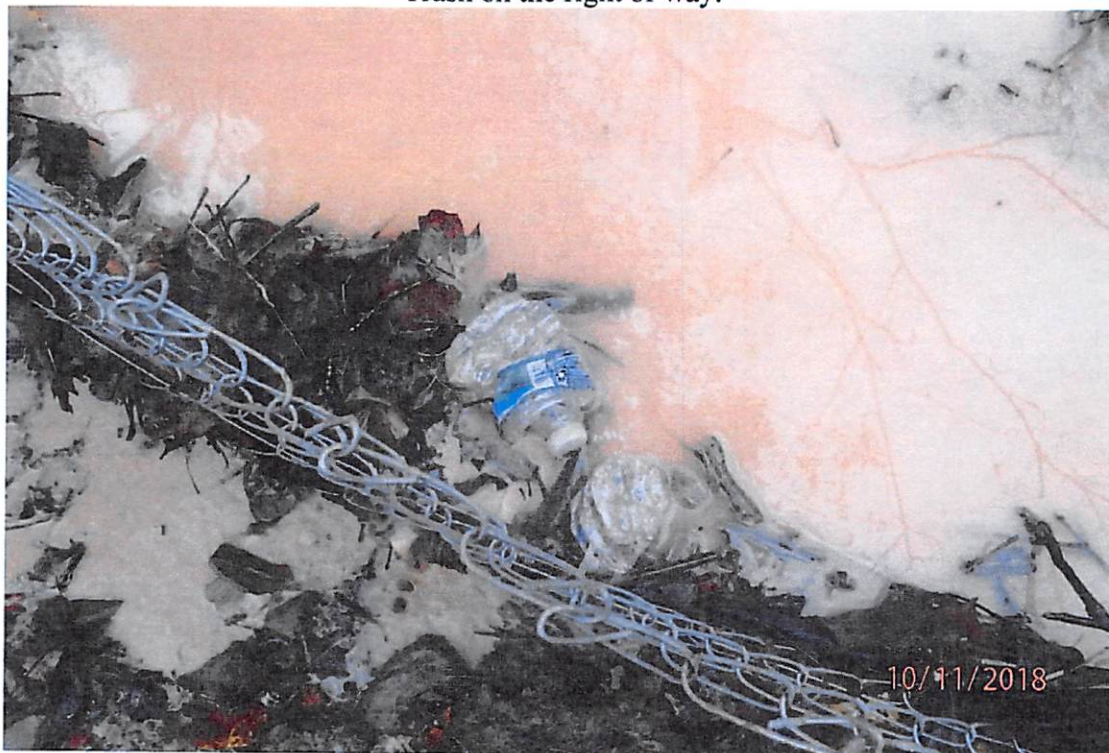
Trash on the right of way.

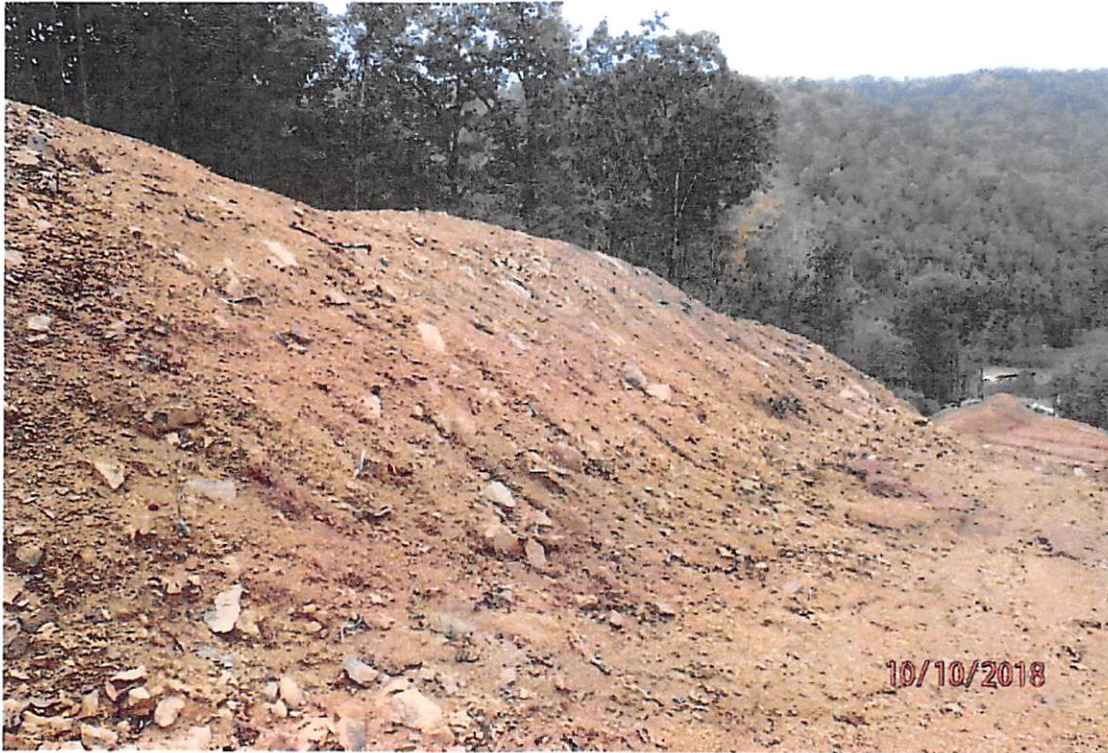
Stockpile that lacks temporary stabilization near 287+00.

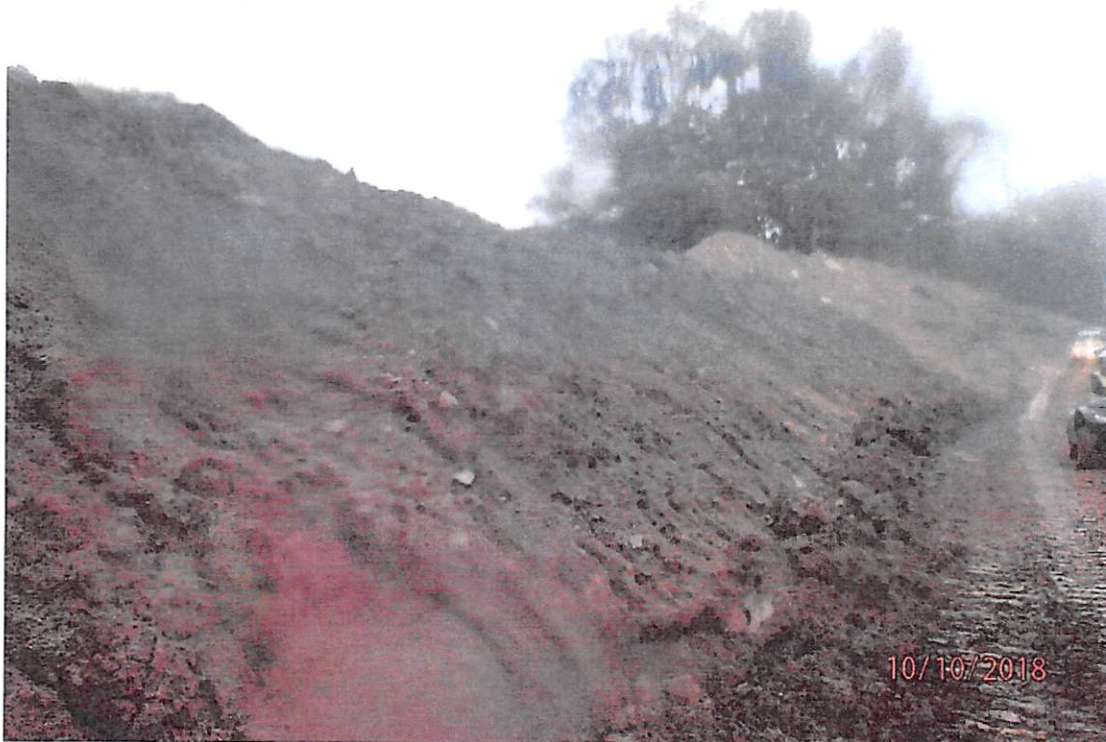
Stockpile that lacks temporary stabilization near 350+80.

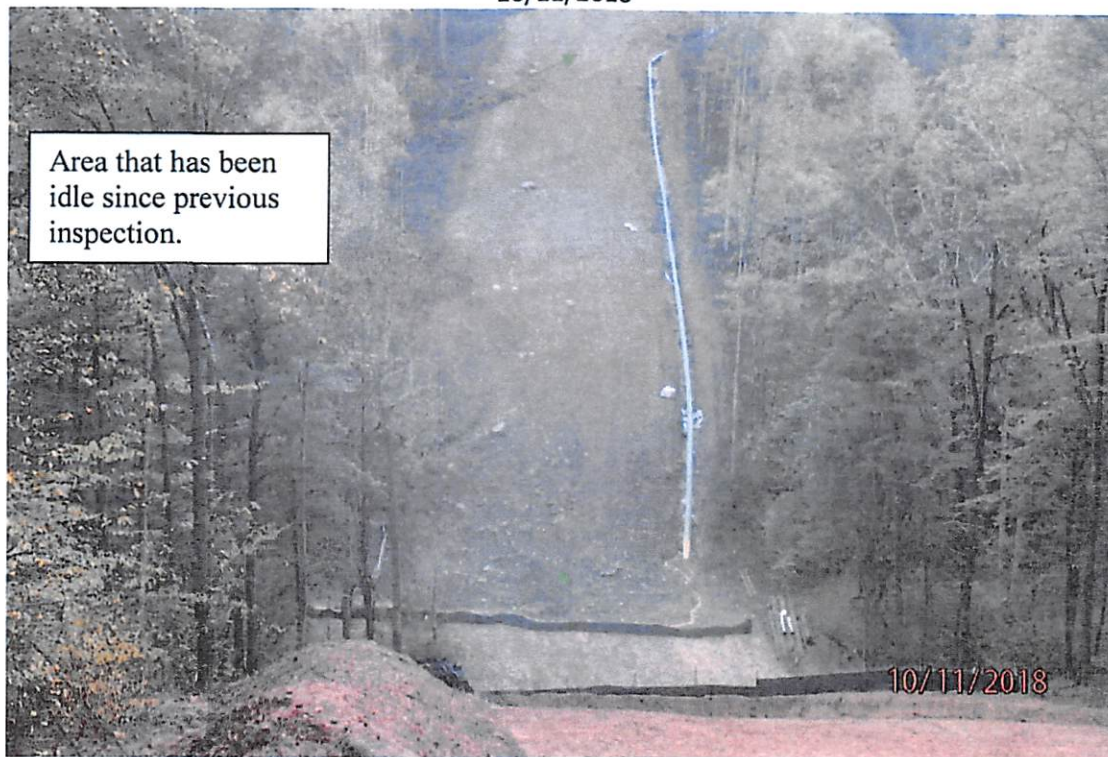
Right of way that lacks temporary stabilization near 862+00.

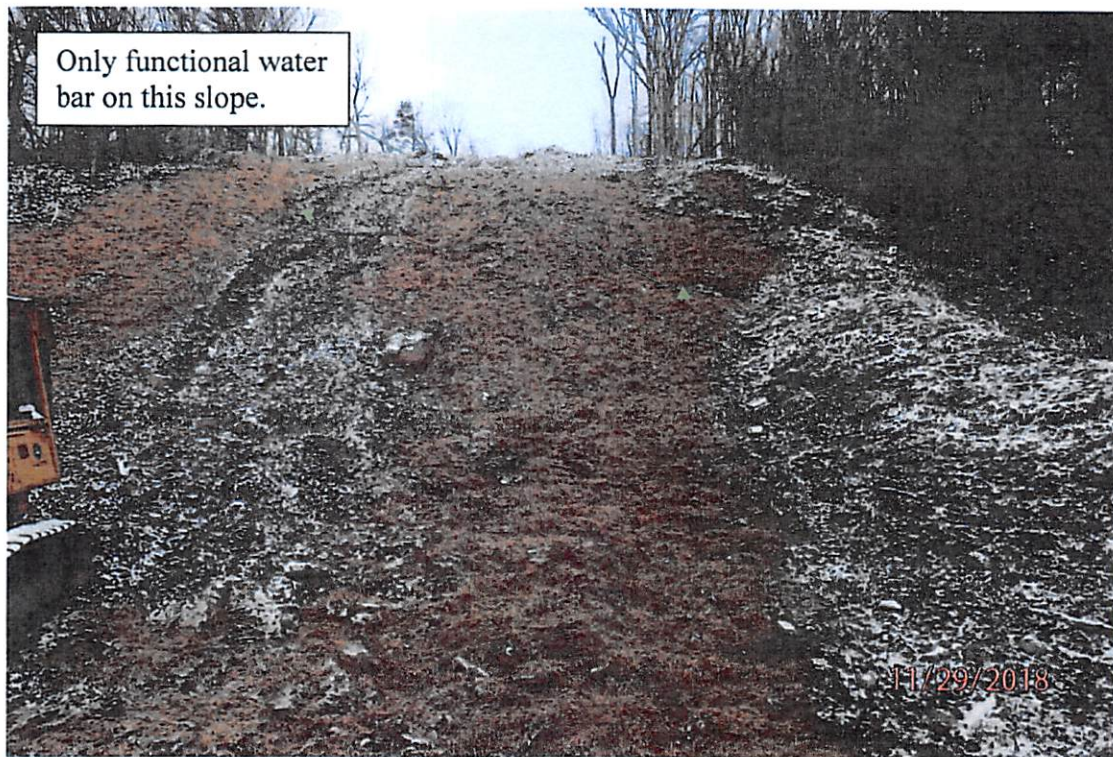
Inspected area from 661+00 to 669+00 showing the lack of water bars as indicated in the approved SWPPP.

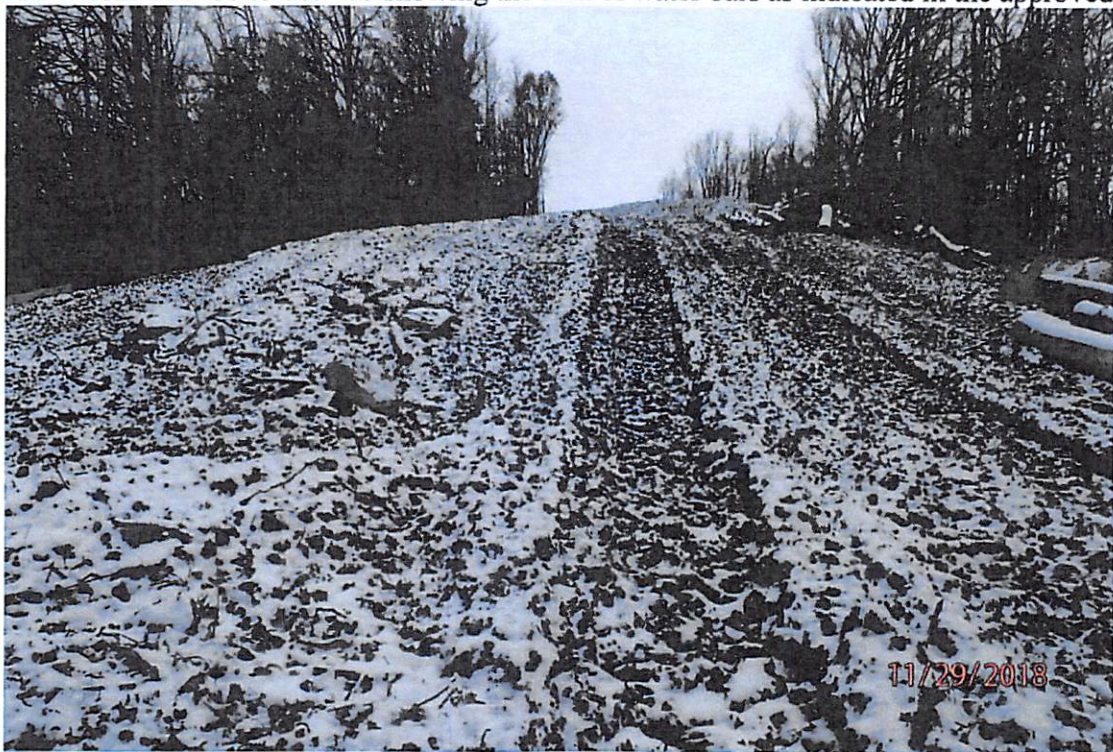
Inspected area from 661+00 to 669+00 showing the lack of water bars as indicated in the approved SWPPP.

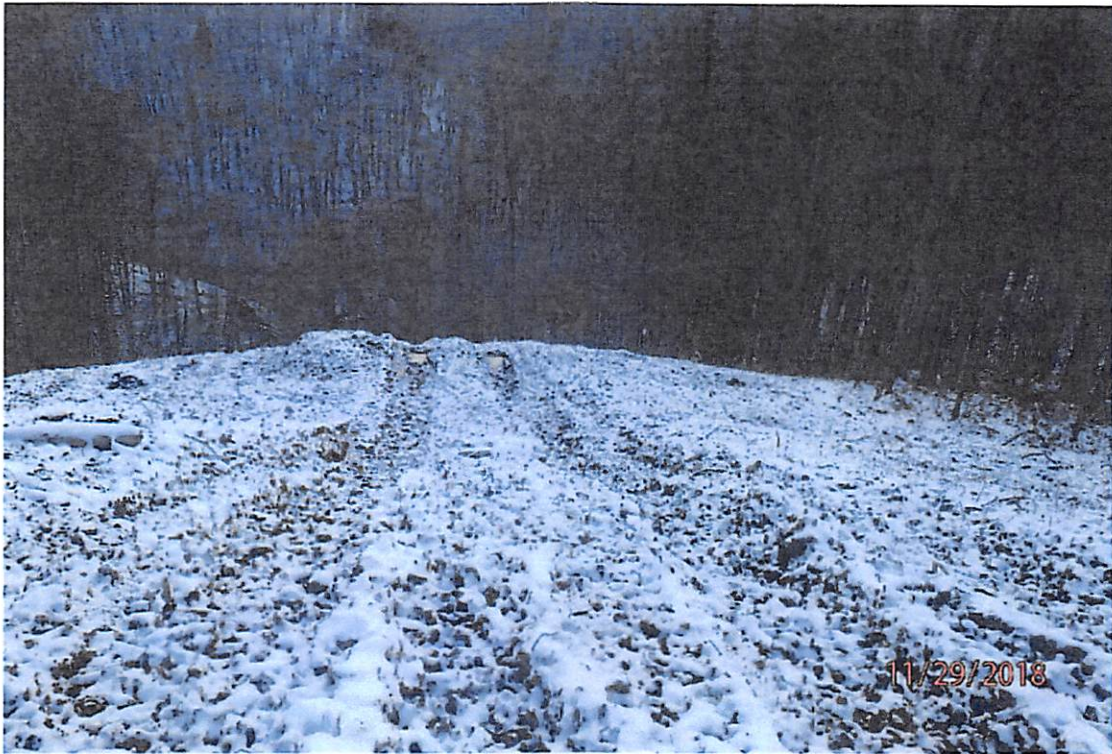
Inspected area from 675+00 to 682+00 showing the lack of water bars as indicated in the approved SWPPP.

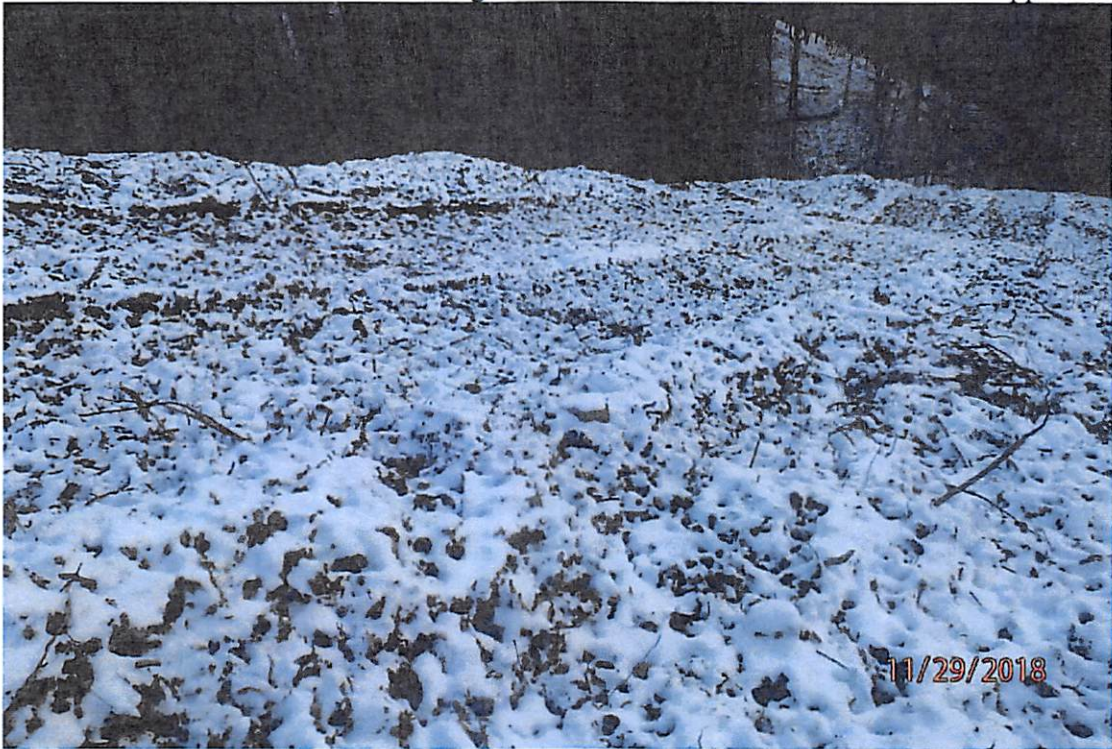
Inspected area from 675+00 to 682+00 showing the lack of water bars as indicated in the approved SWPPP.

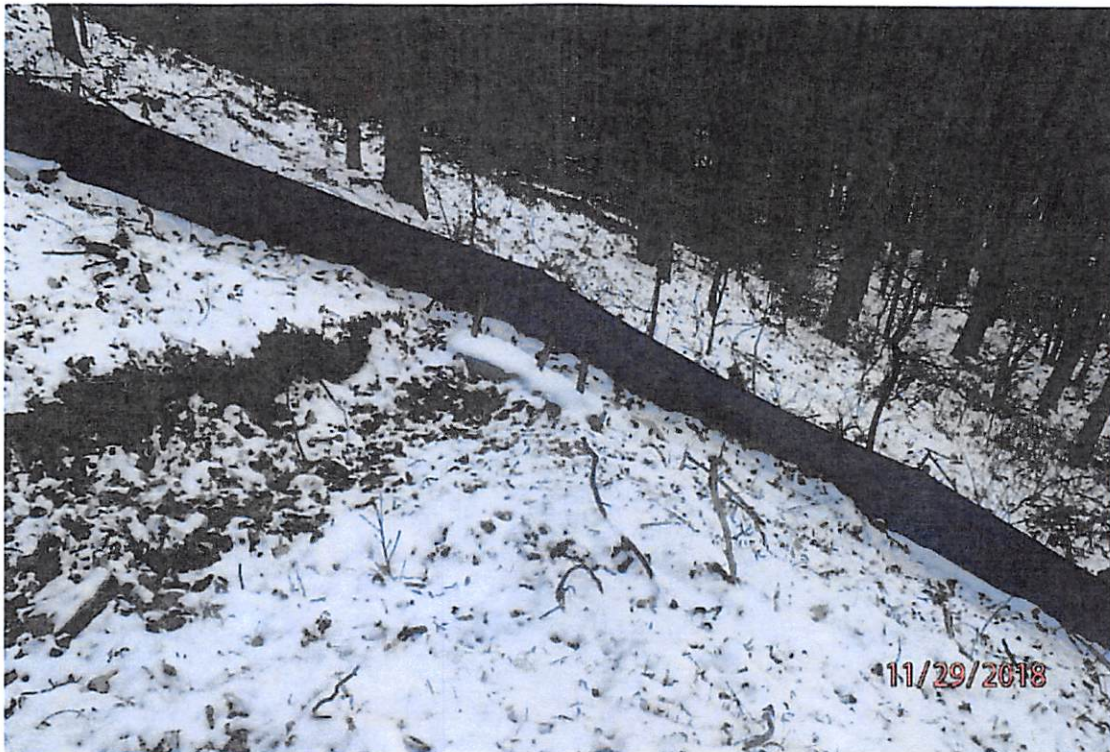
Water bar outlet that does not extend past the installed perimeter controls in the Franks Run watershed.
